Modifying 2003 Ford Ranger Gauge Cluster Theft Light to work with 2000 Ford Ranger

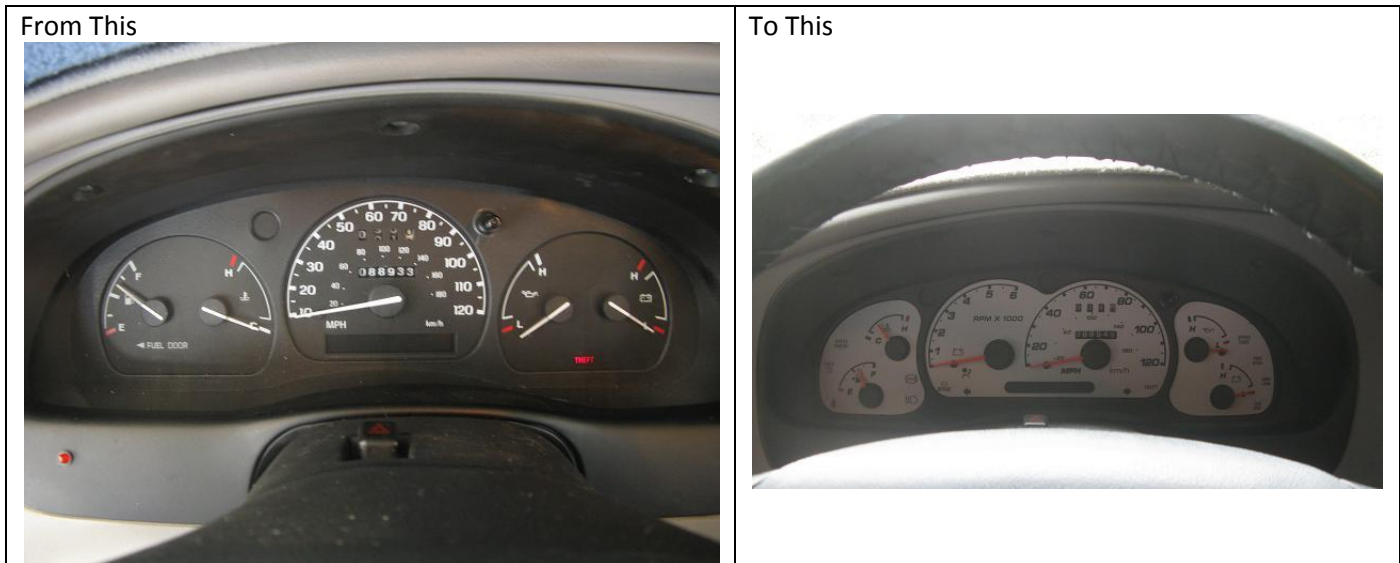
The original you can see the red, Theft light on the right side of the cluster between the oil pressure and battery indicators. The Theft light of the new set up is located on the bottom right corner of the speedometer.

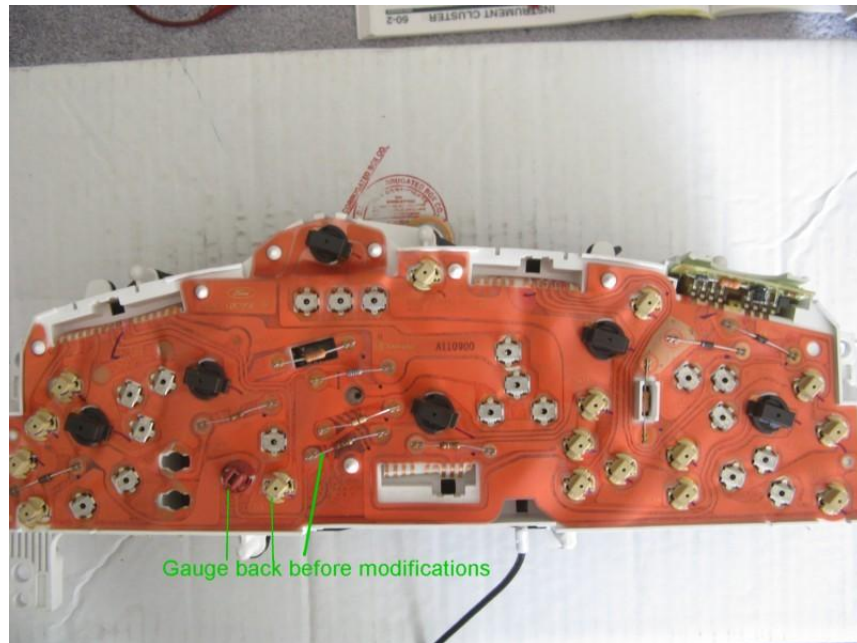
So this is what the back of the gauge cluster looked like before I got into it.

The three lines indicate the original bulb, adjacent bulb and accompanying current limiting resistor.

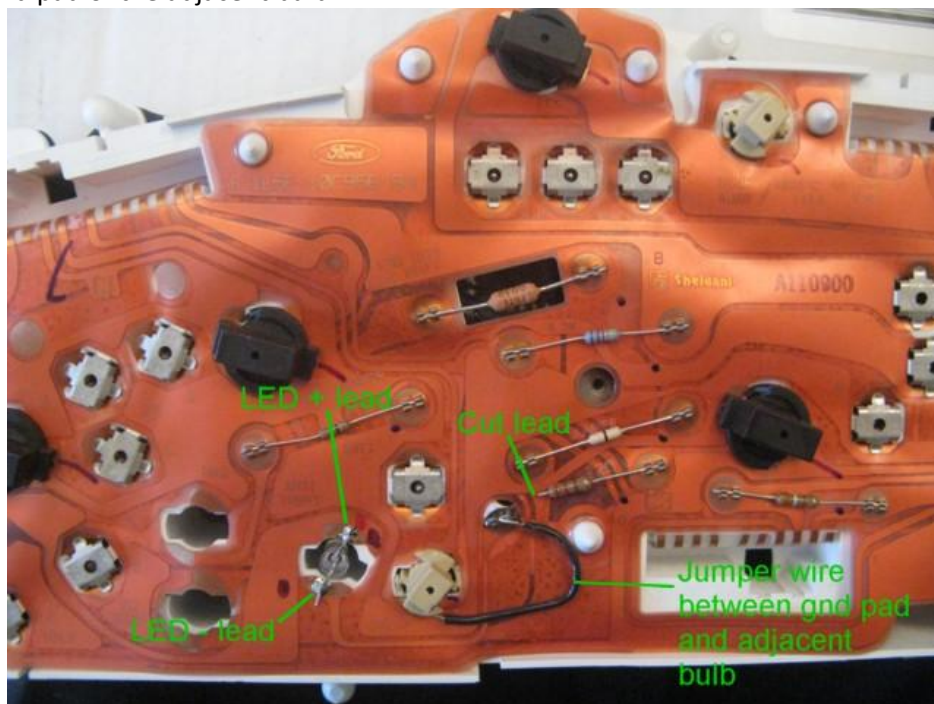
And now here is the back side with modifications:

I removed the old LED, soldered in a new one (polarity in the old one was backwards). Cut the Resistor Lead and soldered in a jumper wire between the gnd pad of the original circuit and the gnd pad of the adjacent bulb.

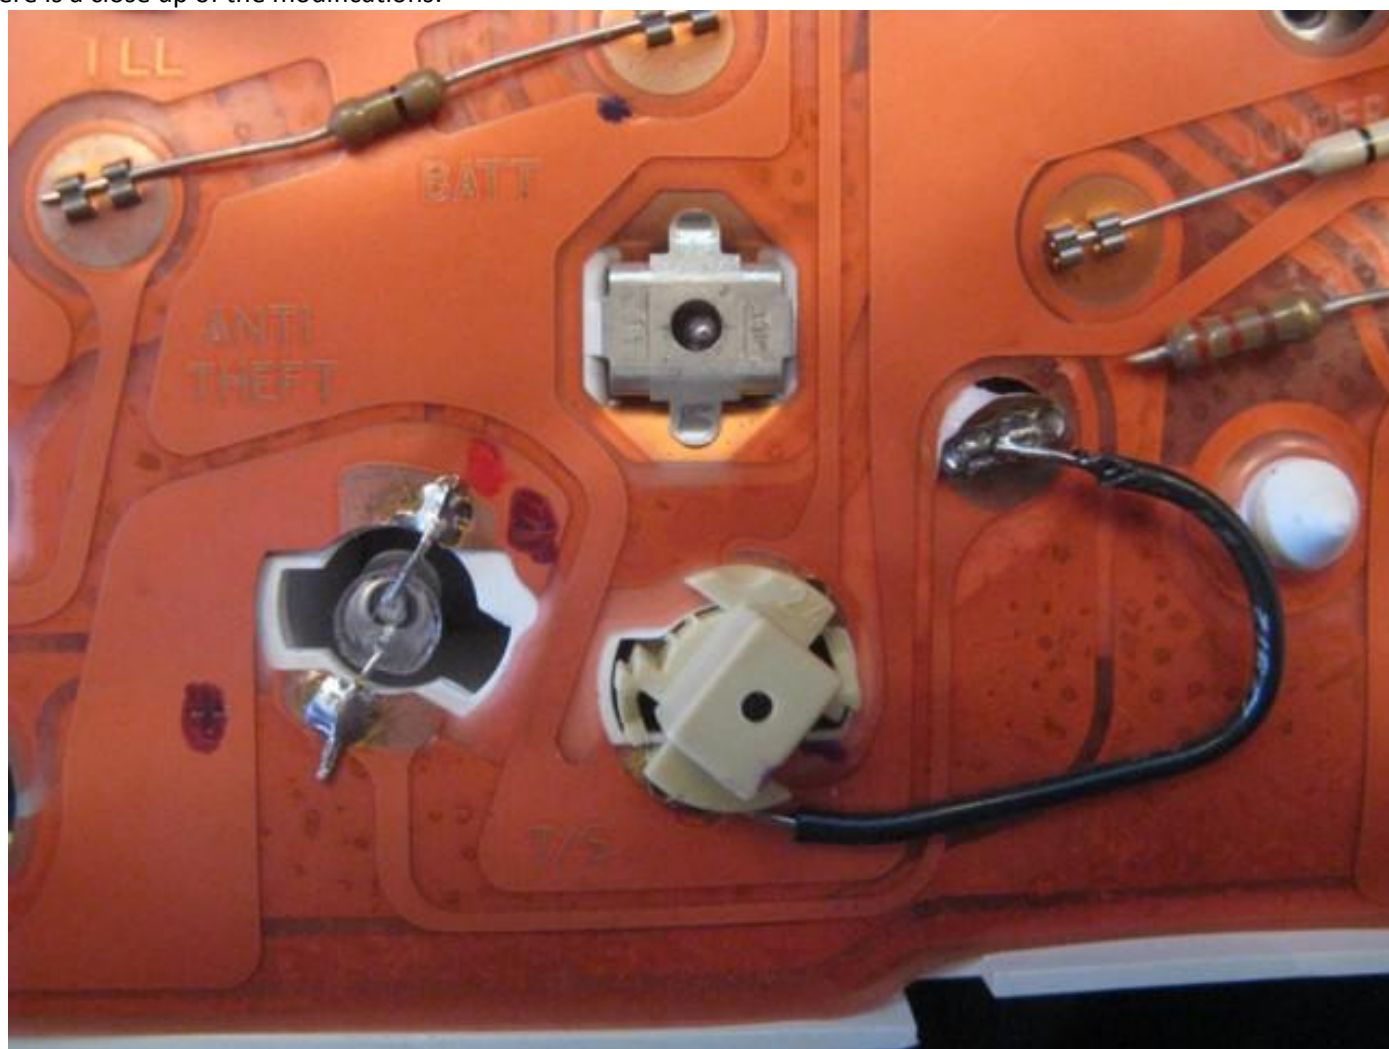
Here is a close up of the modifications:
